IRS Panel

IRS OFF / NAV Select Switch

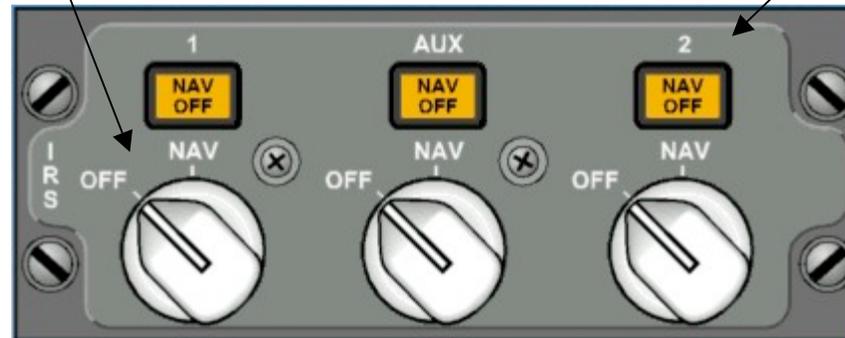
Moving the IRS selectors from OFF to NAV begins a 10 minute alignment period. During this alignment period, the IRS determines the approximate current latitude based on calculations using the motion measured from the rotation of the Earth. The calculated latitude is then compared to the present position latitude from the FMS INIT page when the "INITIALIZE IRS" prompt is selected. A significant mismatch between the calculated latitude and the latitude entered from the INIT page will result in a failed alignment. Longitude cannot be calculated during initialization in the same manner. However, the longitude from the last shutdown is stored and used as a reasonableness check during the next alignment. Pressing the "INITIALIZE IRS" prompt when a significant (assumed) longitude position error exists will also result in a failed alignment. Any failed alignment will be indicated by flashing NAV OFF lights, level 1 "IRU 1 NO ALIGN, IRU 2 NO ALIGN and IRU AUX NO ALIGN" alerts, and a Master Caution alert.

A rapid alignment (appx 3 mins) may be accomplished by moving the IRS switches from NAV to OFF, then back to NAV within 5 seconds. Realignment will then be initialized with the existing attitude and heading. Velocities will be zeroed.

NAV OFF (light)

Extinguished – Alignment is complete, operating in NAV mode

Steady On – IRS system is either off, in align mode, or has failed

Flashing – Position not entered within ten minutes, present latitude does not agree with calculated position in the IRU, or the IRU has sensed motion during the alignment phase.
